NATICK POND DAM

R.I. 03801

PHASE I INSPECTION REPORT
NATIONAL DAM INSPECTION PROGRAM

JUNE 1979

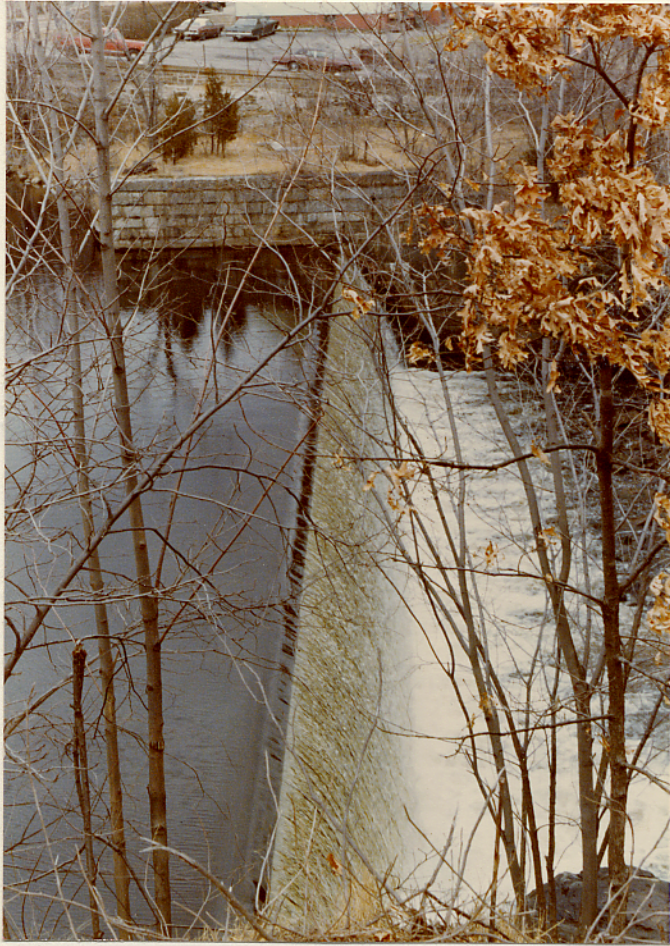
Overview Photo from right abutment

b. Dam. The dam is a run-of-the-river dam with an overall length of about 263 ft. The right granite masonry abutment is founded on bedrock, which is well exposed for a distance of about 500 ft. downstream of the dam. The left abutment contains a filled-in mill race which formerly contained six wooden trench gates; these were demolished in 1974. The mill race below the gates formerly connected to a mill downstream on the left bank of the river. There is an earth fill between the left training wall of the spillway and the right training wall of the mill race (See Photo Nos. 3 & 4, Appendix C). Several small trees are growing in this area. The earth fill is shown to be a "puddle" fill, according to an old drawing. The base of the dam is founded on bedrock. The old mill race has been filled in for a distance of approximately 300 ft. downstream of the dam. The fill appears to be of a very blocky rock type, which may have voids in it. However, at the upstream end, the fill appears to be more sandy, containing more fines. These fines extend downstream for a distance of 20 to 30 ft. No evidence of any major seepage through this area was noted. (See Overview Photo, Page V)

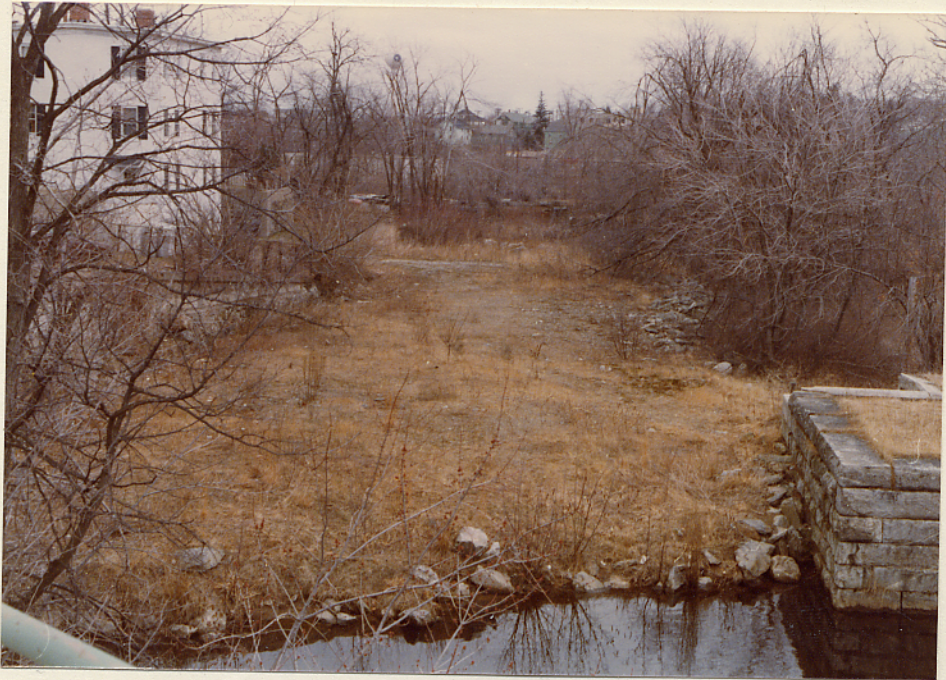
(2) Old Mill Raceway. Beyond the filled-in portion of the raceway, the old mill race runs through an abandoned and demolished mill building and then through the 10 ft. dia. deteriorated arch flumes that connect to the river. (See Photo No. 1, Appendix C).

1. Downstream view of old mill raceway.

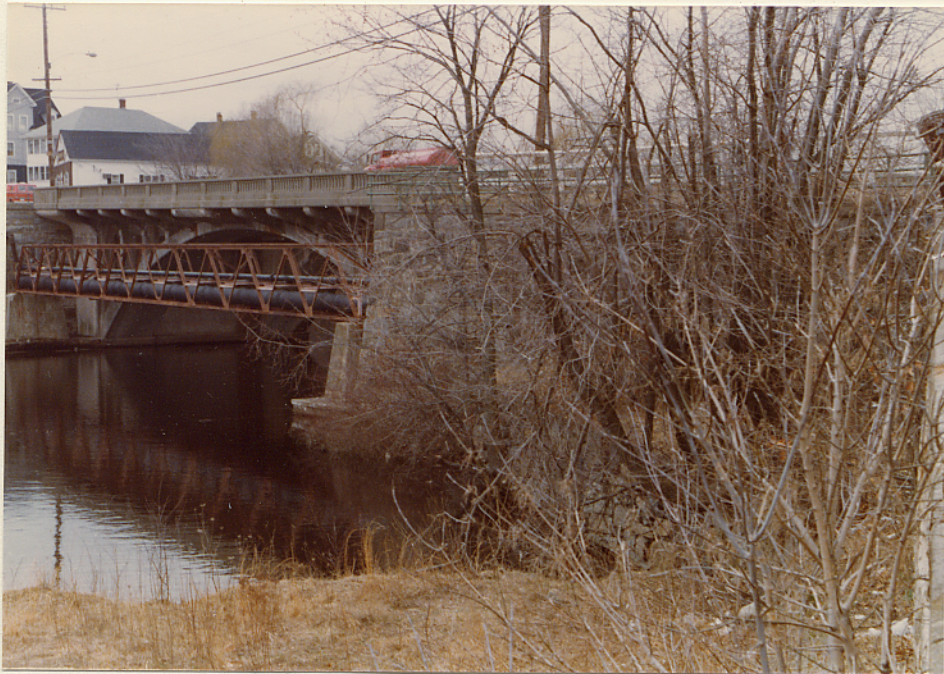
2. View of Rt. 33 immediately upstream of project.

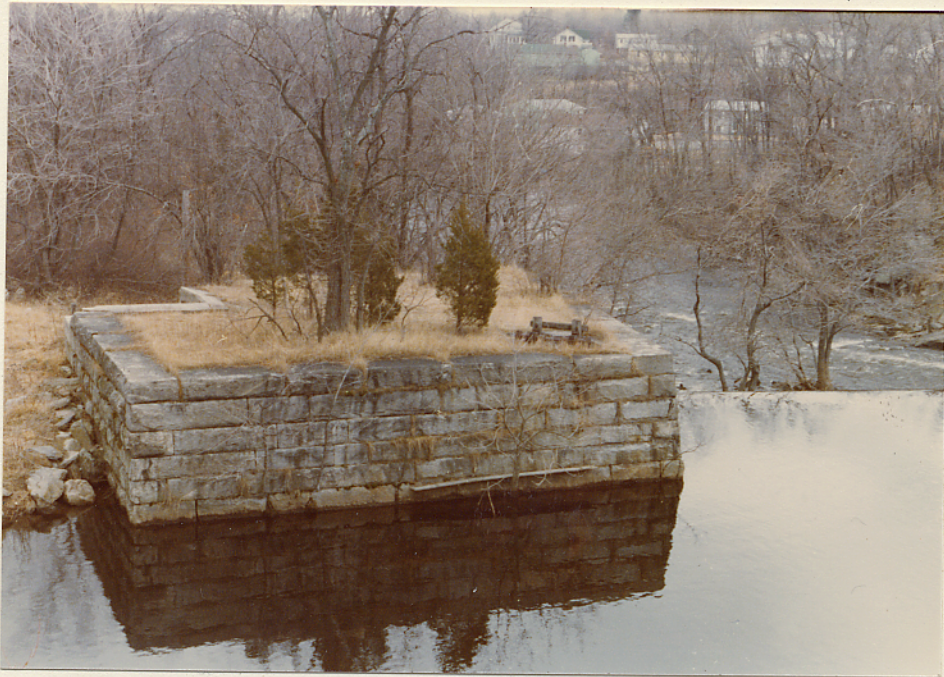
3. Abandoned outlet gate controls.

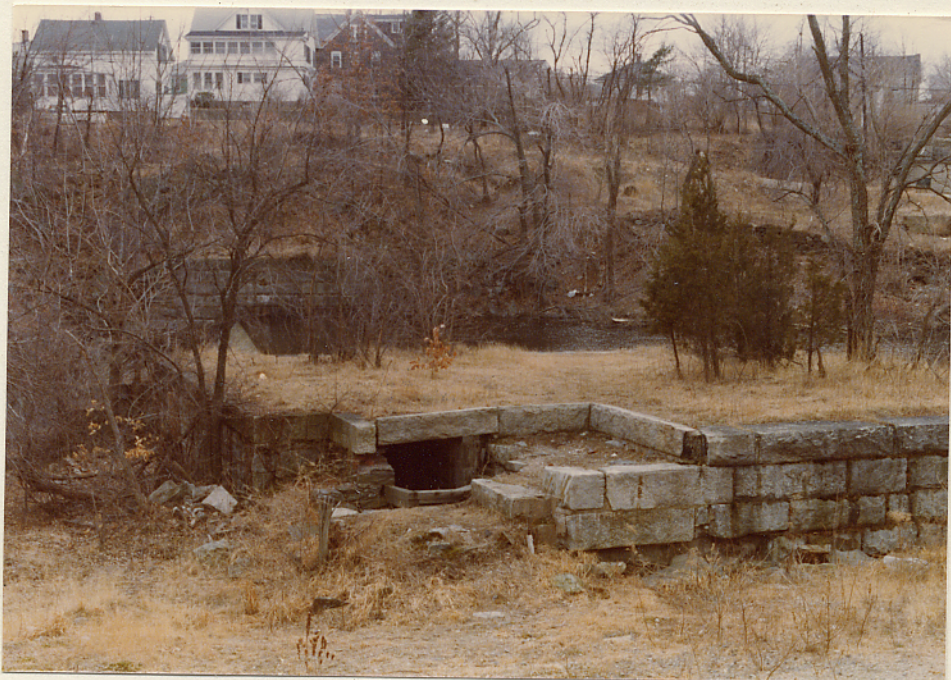
4. View of outlet structure and spillway crest from left abutment.

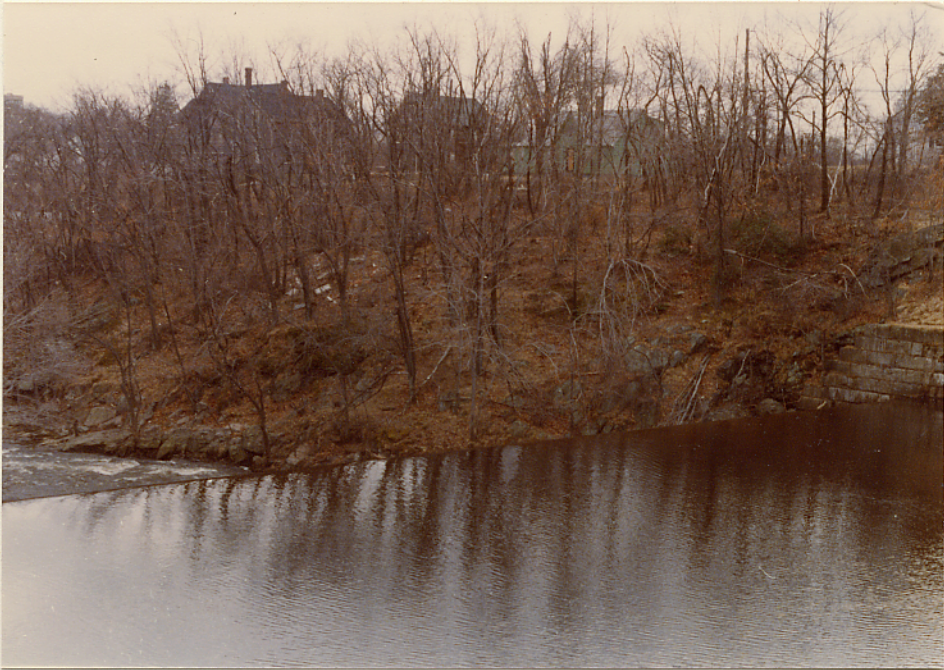
5. View of right river bank immediately downstream
from project.
